NWE-HEB-3995

December 9, 2021

Re: NorthWestern Energy report of a deviation from Project 2188 Article 403 at the Hebgen Development

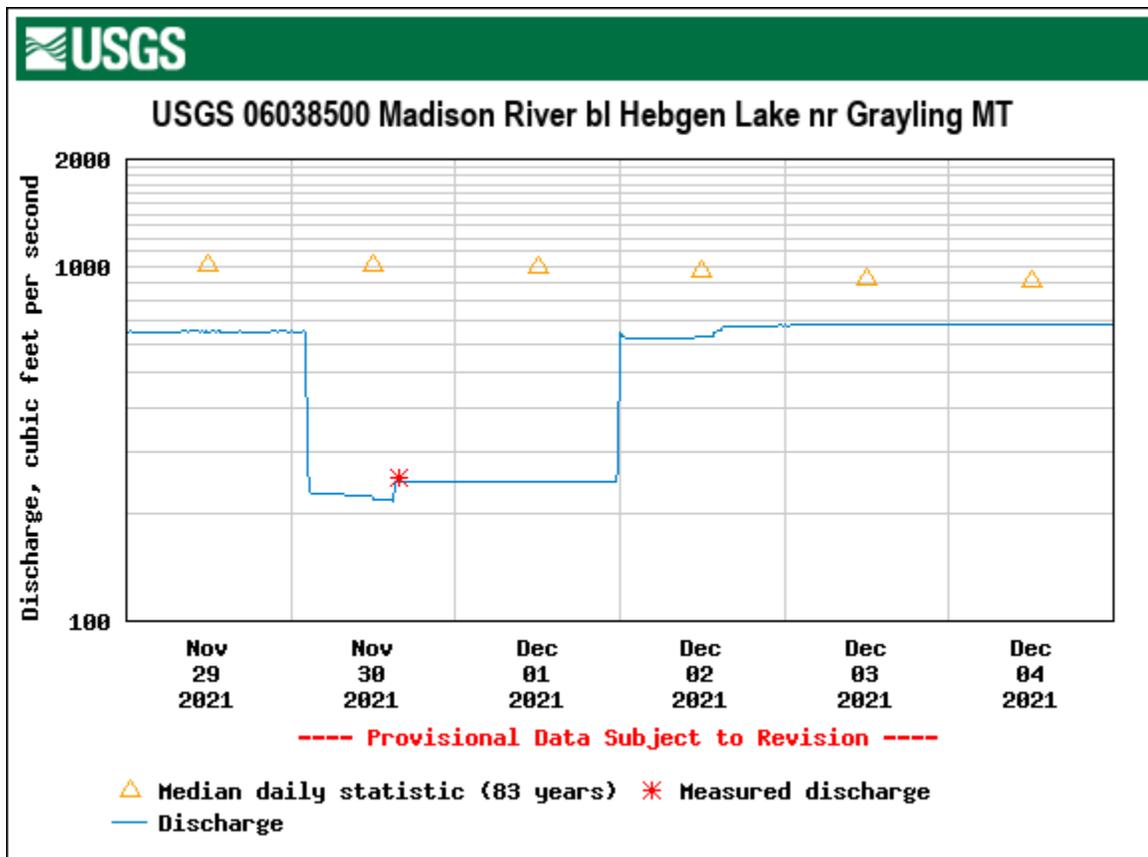
During the event, the USGS Gauge measured outflow at Hebgen dropped from 648 cfs to 278 cfs within a 15 minute period (a reduction of 57%) and a maximum reduction down to 216 cfs (a reduction of 67%) within a 24-hour period. This change in outflow volume equated to a drop of 0.76 feet of stage (water elevation) in the river. Hebgen outflows, as measured at USGS Gauge No 06038500, remained above the Article 403 minimum of 150 cfs for the duration of the event.

USGS Gauge No 06038500 data below Hebgen Dam is presented below.

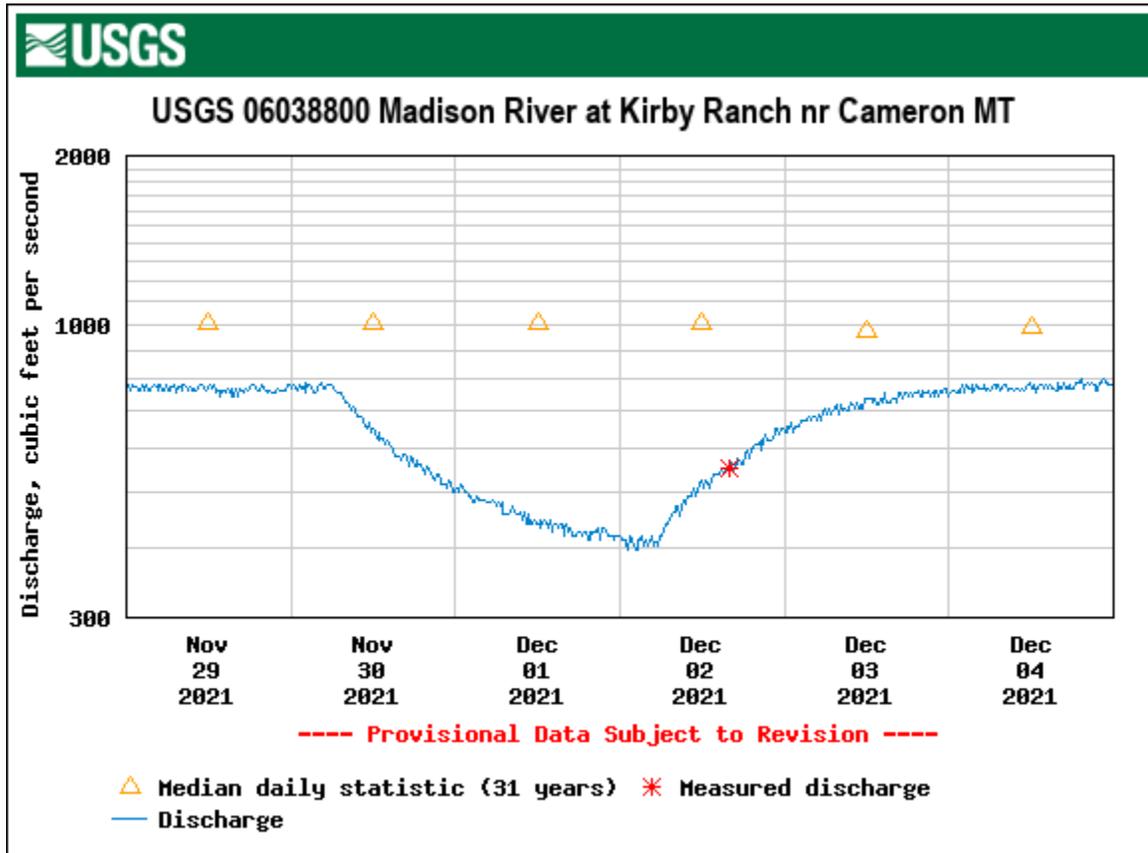
During the event, Hebgen outflows ranged from 216 to 248 cfs for approximately 46 hours. Quake Lake, two miles downstream of Hebgen Reservoir, helped to attenuate flow changes in the Madison River downstream resulting in a gradual reduction of flows. Madison River flows dropped below the 600 cfs Article 403 minimum at Kirby Ranch 12 miles downstream at 14:30 on November 30th and reduced slowly to a minimum of 395 cfs at 02:15 on December 2nd. Flows increased at Kirby Ranch after Hebgen outflows were restored and ample travel time provided

for the water to be conveyed downstream. Flows above 600 cfs were restored in the Madison River at Kirby Ranch at 19:15 on December 2nd.

USGS Gauge No 06038800 data at Kirby Ranch is presented below.
